APPLICATION OF UNDERWATER ACOUSTIC REMOTE SENSING
DAM AND IMPOUNDMENT SYSTEM EXAMINATION
CASE STUDY EXAMPLES

Bayou D' Arbonne Dam – Near Farmerville, LA

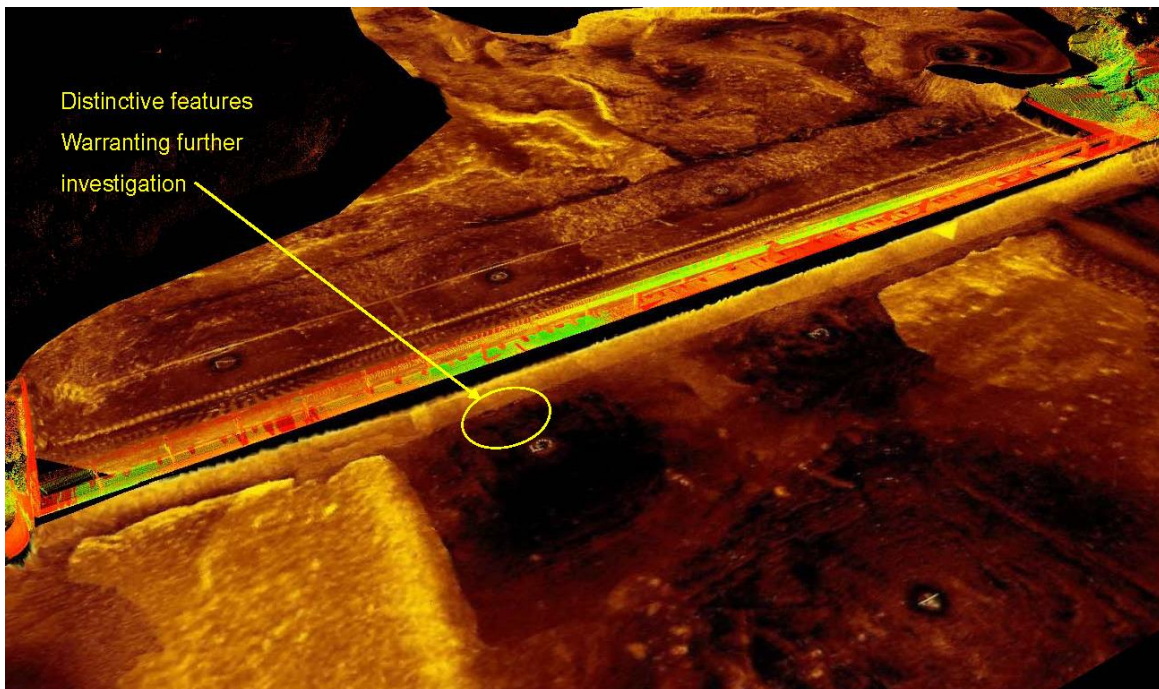
Key observations during the course of this project were a water flow transiting through the dam spillway structure, indicated by the existence of two small holes in the sediment at the interface of the water bottom and the heel of the dam, and a corresponding high velocity water stream exiting near the lower dispersion blocks downstream and in alignment with the holes in the sediment.

Detection of washout holes at the toe of the upstream slabs.

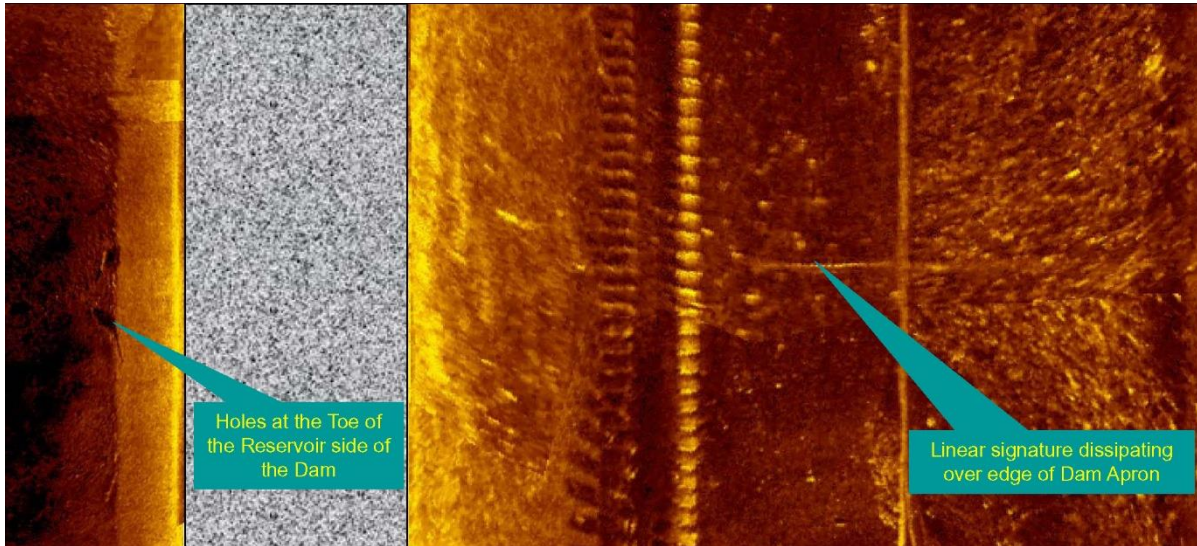
Washout holes and correlated high velocity water discharge downstream, from dispersion blocks on the spillway apron.

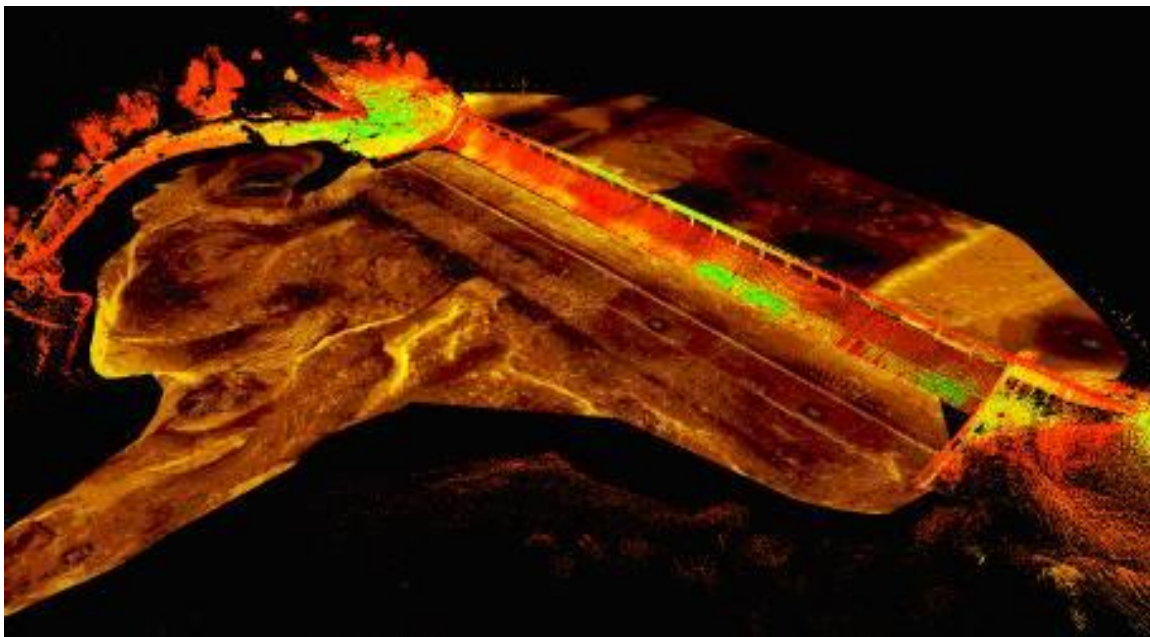
Another key observation was the convoluted erosion pattern which indicated the water flow path over the spillway and through the sluice gates discharging downstream. The channelization had evolved into a deviation far from the design and was threatening the backside of the southern embankment.

Three dimensional composite model of the as-found condition of the D'Arbonne Dam and surrounding dam system environment

Both of these significant observations provided the owner the information to develop a targeted plan of action for maintenance rehabilitation of the structure.

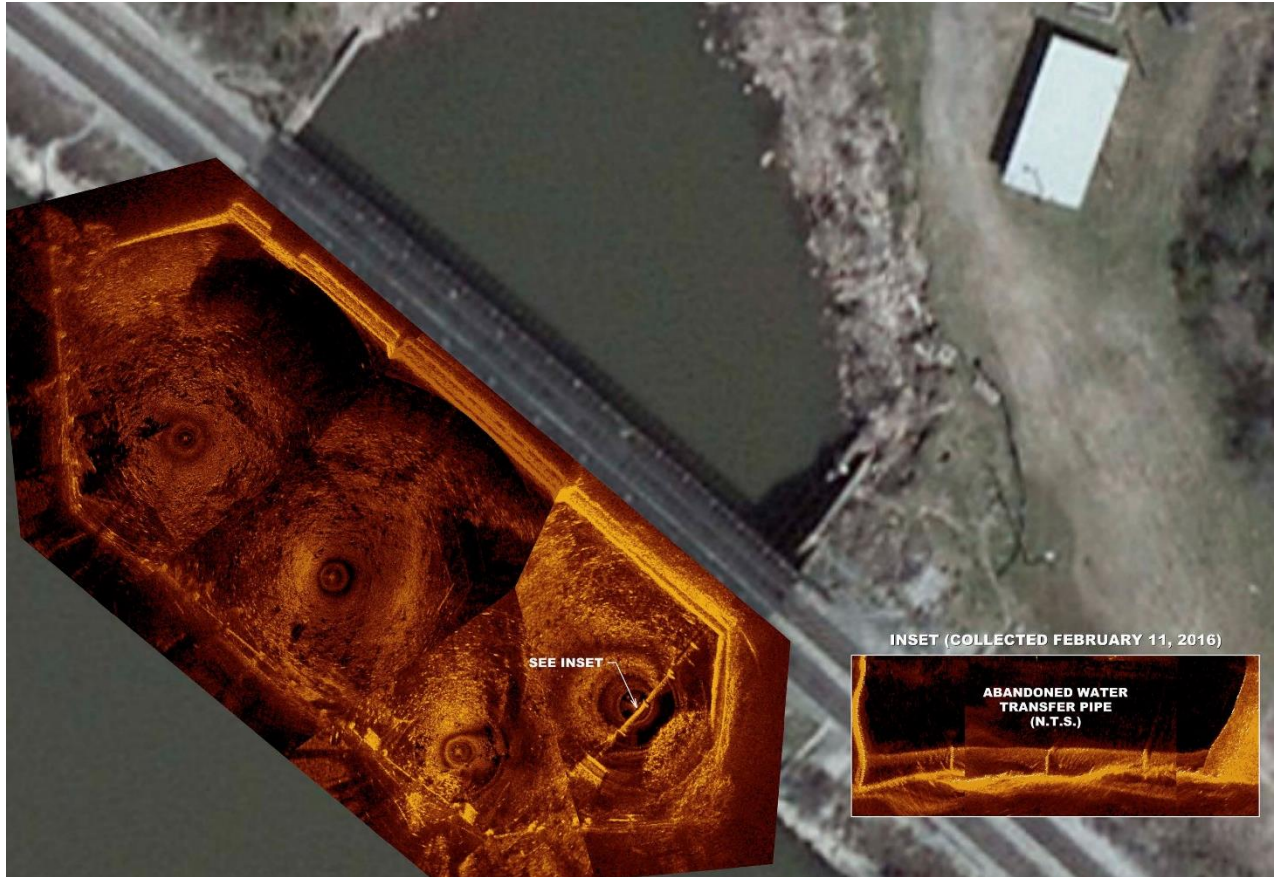
The UAI imagery showed a degrading concrete surface with exposed aggregate throughout the submerged components of the structure, and instances of shallow voids as is typical of aging concrete structures. Also observed was the abandoned steel water transfer pipe penetrating through the concrete spillway, and the adjacent decommissioned pipe which is terminated near the spillway structure on both sides. An inspection of the submerged components of the active water intake approximately one mile from the spillway was also performed, showing debris accumulation and light damage to the intake grates.
