APPLICATION OF UNDERWATER ACOUSTIC REMOTE SENSING
DAM AND IMPOUNDMENT SYSTEM EXAMINATION
CASE STUDY EXAMPLES

Bayou D' Arbonne Dam – Near Farmerville, LA

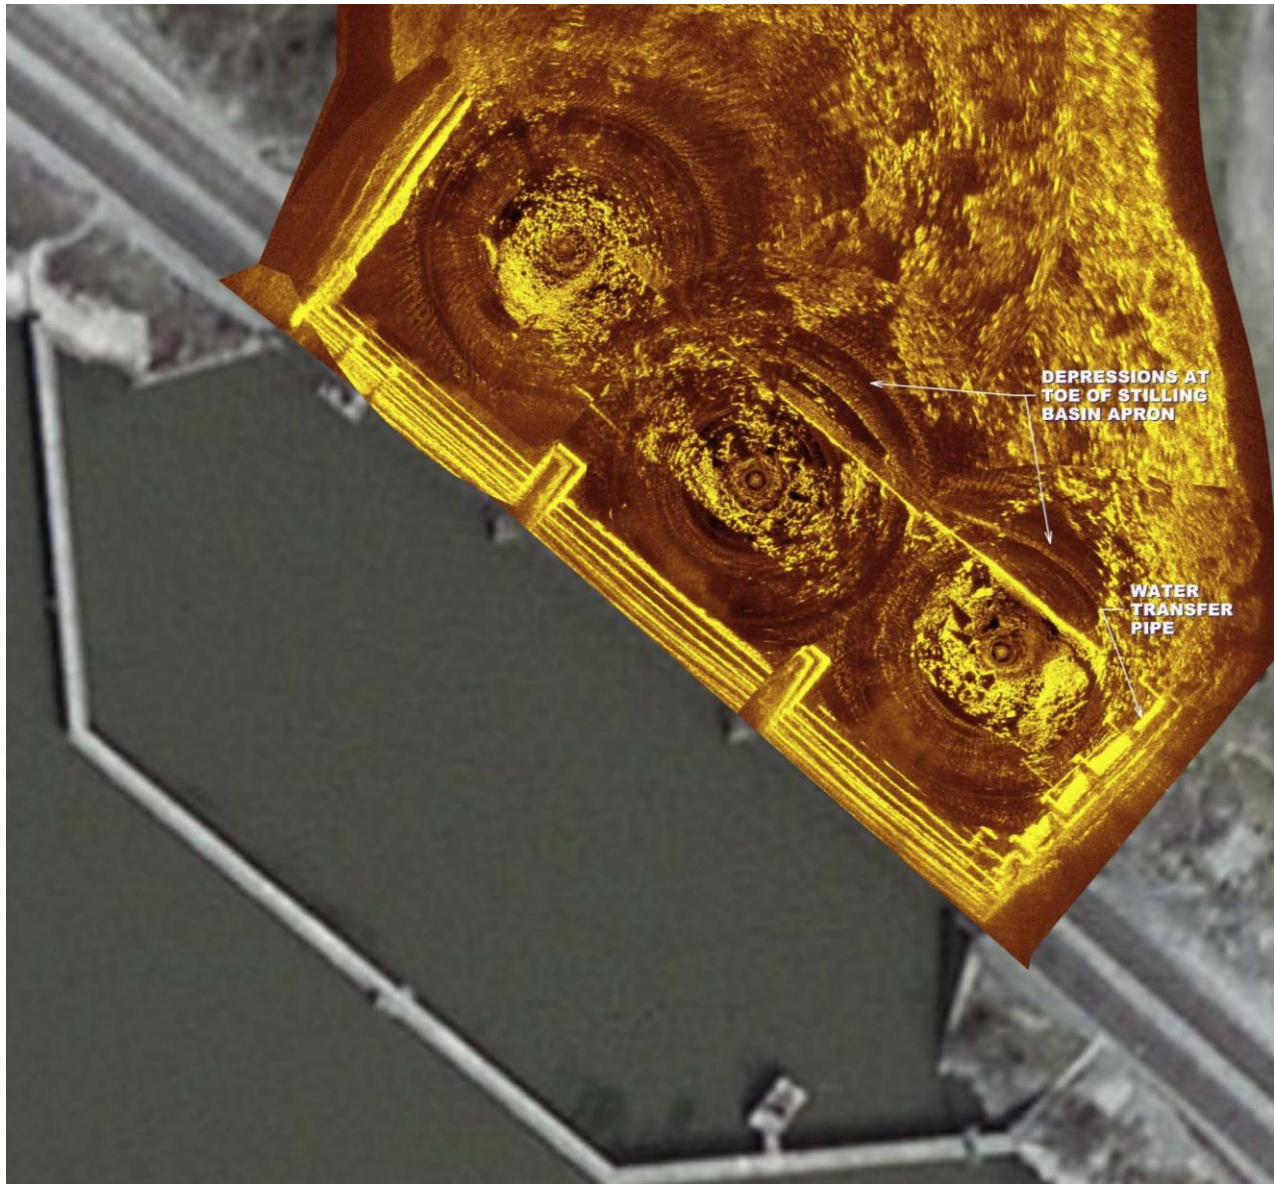
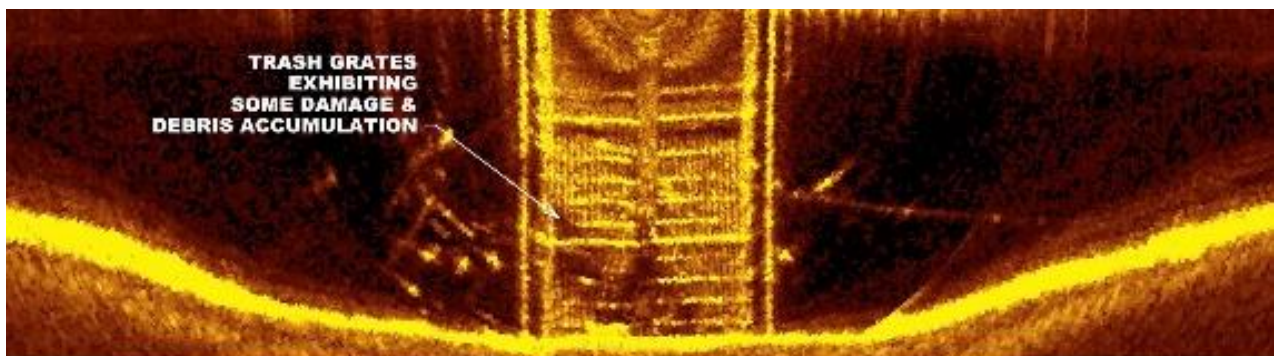
The UAI imagery showed a degrading concrete surface with exposed aggregate throughout the submerged components of the structure, and instances of shallow voids as is typical of aging concrete structures. Also observed was the abandoned steel water transfer pipe penetrating through the concrete spillway, and the adjacent decommissioned pipe which is terminated near the spillway structure on both sides. An inspection of the submerged components of the active water intake approximately one mile from the spillway was also performed, showing debris accumulation and light damage to the intake grates.
