Field Test of a Geotextile-Reinforced Levee

REDA M. BAKEER, TARIK A. HADJ-HAMOU, FRANK M. DUARTE, AND GERARD S. SATTERLEE

The field performance of a full-scale test section of a geotextile-reinforced embankment founded on a soil deposit of mostly soft clays is discussed. The test section was constructed in 1986 under the supervision of the U.S. Army Corps of Engineers as an enlargement prototype of an existing hurricane protection levee. The section was built to test the performance of the proposed design prior to commencing work on the entire 13-mi (20.8-km) span. The soil investigation conducted by the Corps included undisturbed and disturbed borings, soil sampling, and laboratory testing. The test section was fully instrumented with inclinometers, settlement plates, and piezometers. Displacement transducers were used to measure the deformations in the fabric. Field measurements consisted of horizontal movements, vertical settlements, pore pressures, and strains in the fabric. Measurements were taken during construction and continued for 2 years.

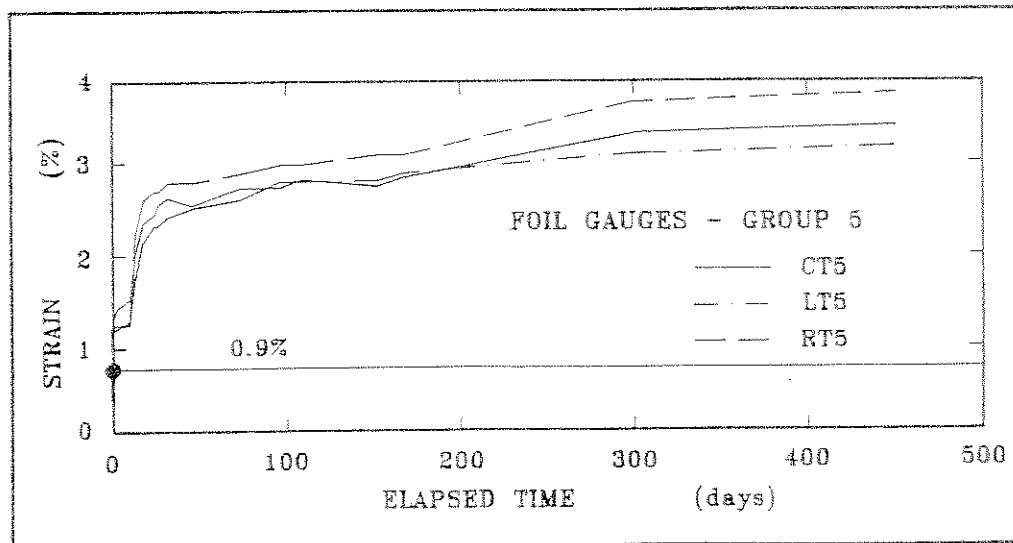
FIGURE 8 Strains in the fabric.

Typical lateral strains measured in the fabric by the foil gauges during the first 300 days are shown on Figure 8 for Group 5 (CT-5, LT-5, and RT-5). The readings of other groups of gauges followed similar patterns. The lowest strain of 0.8 percent was measured by gauges LT-1 and LT-2, and the maximum lateral strain was 2.3 percent at gauge RT-5. On average, a maximum strain of 2.3 percent was measured by Group 5 of lateral gauges, located near the fold on the Gulf side, and a minimum strain of 0.97 percent at Group 4. A gradual decrease in strain was observed toward the slope on the canal side, except for an inconsistent reading of Group 4. The 300 days readings of RT-4 and CT-4 were small (0.3 and 1.0 percent) in comparison with the reading of 1.6 percent at LT-4 (maximum difference of 1.5 percent) and the average readings of Groups 3 and 5 of 1.4 and 2.3 percent, respec-

tively. In addition, lower strains were observed at Group 2 of gauges, located at the toe of the existing embankment (bend in the fabric), than in Groups 1 and 3, located before and after the toe.

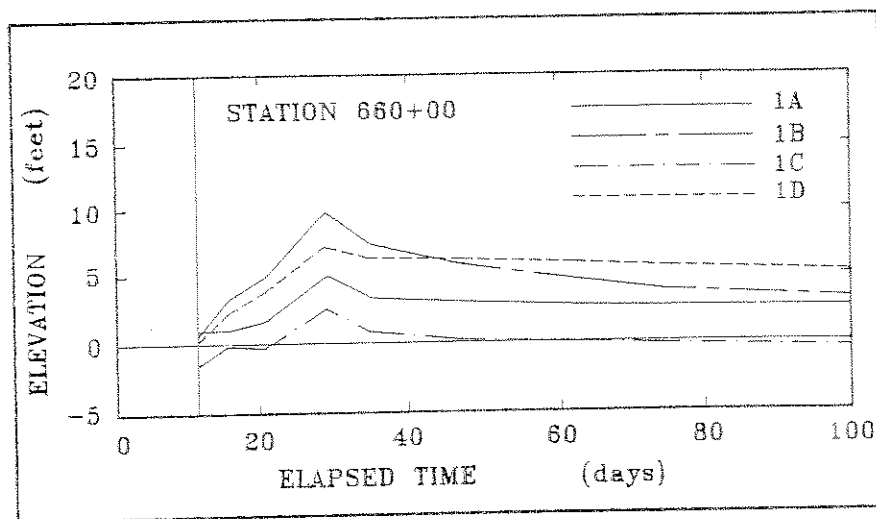
FIGURE 11 Pore pressures in subsoils.

(1.25, 2.75, 1.12, and 2.17 m), respectively. A reduction in the pore pressure of 28 percent occurred in the four days after reaching the design grade of the levee. This rapid reduction is indicative of the quick process of consolidation in these clays. The maximum average increase in pore pressure of 9.03 ft (2.77 m) is equivalent to about 64 percent of the added fill of 8.5 ft (2.9 m) between elevations 5 and 13.5 ft (1.53 to 4.11 m) when the last reading was taken during construction. It should be noted that removal of the top soil of the existing levee may have resulted in negative initial pressures, and no readings were taken just after completion, which allowed pore pressures to dissipate somewhat. The highest residual pressure of 5 ft (1.53 m) was measured by the deepest piezometers, D, located in the bottom thick clay layer of very low permeability and poor drainage conditions. On the other hand, the quick dissipation of the pressure in piezometers B and C is due to their location between relatively highly permeable lay-

ers of sand or silt. Piezometers A, by contrast, are located in the middle of the top CH layer, just below the clay levee, and accordingly measured much slower decays.

As expected, the pattern of settlement at the fabric level followed that of the pore pressures, with measurable increase in settlement recorded during the construction phase of lifts 2 through 8 (refer to Figures 2, 11, and 12). The rate of settlement decreased considerably after 150 days, and no measurable increase in the settlement was recorded after 300 days. The two settlement plates on the side slope, S-3 and S-4, showed identical readings, but an average difference of
